EFFECT OF PROTECTING COVERS FOR TEFC INDUCTION MOTORS COVERED BY PULP

ABSTRACT

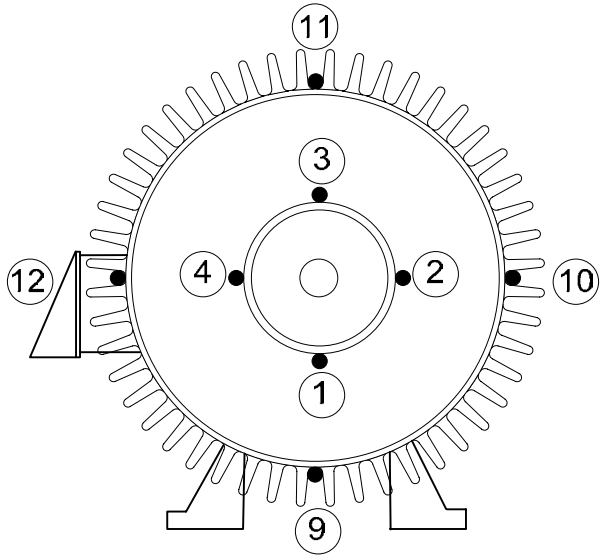
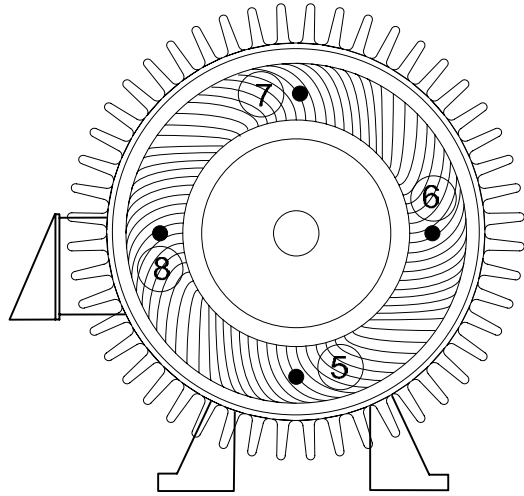
a. Thermocouples location in slots and enclosure

b. Thermocouples location in the end-turn windings

Fig. 2. Numeration and location of thermocouples in the motor

Setup is a variation of the setup used in [1]. Testing motor is a 9.2 kW, TEFC, 4 pole, class F insulation, induction motor with 14 thermocouples located in the spots of interest. Table I lists the thermocouples location, and Fig. 1 is a general view of the setup. Compared to the setup reported in [1], two thermocouples were added in the motor frame, in the interfin channels that become cut by the terminal box. Rest of thermocouples are arranged in groups of four, that cover each radial quarter of the motor (upper, bottom, right, left); groups are installed in the center of stator slots between upper and bottom coils, in the winding end turns, and in the enclosure (see Fig.2 a) and b)). Fig. 3 shows a detailed view of the thermocouples location inside the stator slots and end-turn windings, and in the enclosure.

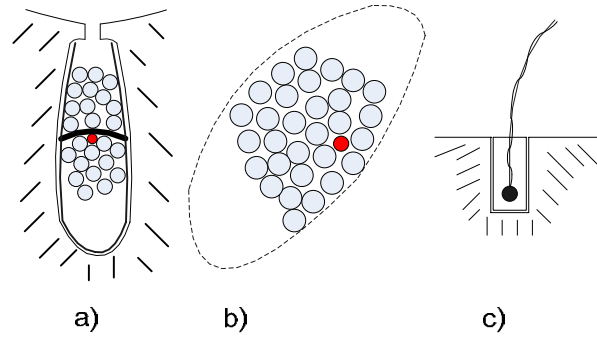
Fig.3. Detailed view of thermocouples location a). stator slots, b). end-turn winding, and c). enclosure

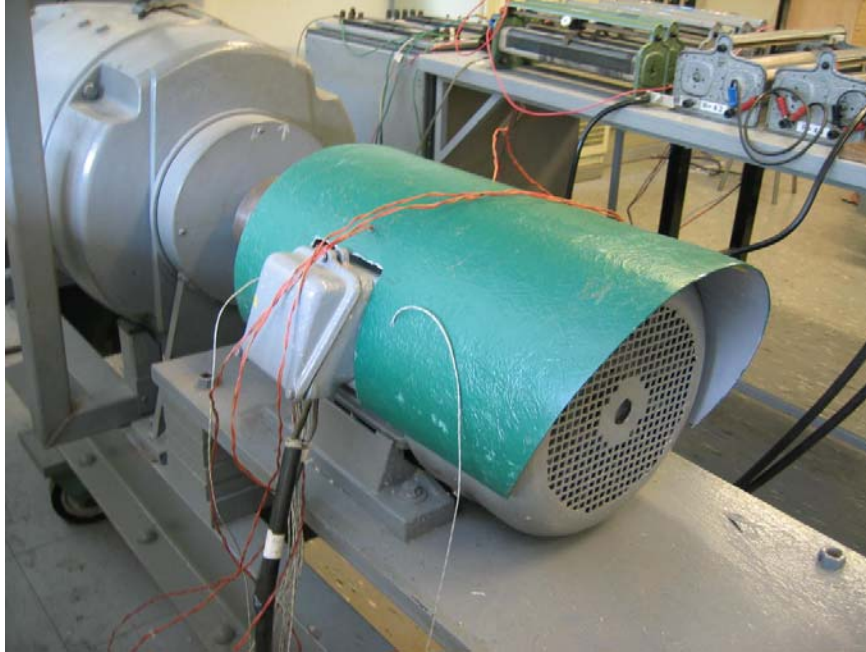
First, the effect of protecting cover is evaluated on a clean motor. Fig. 4 shows a view of the motor with the cover. It can be seen that the protecting cover surrounds the entire motor frame, with the exception of the bottom radial quarter, and therefore bringing an effective protection against the deposit of pulp in any interfin channel. Its design also includes an extension over the fan cover that avoids (or reduces) the possibility of spilled pulp or flying fibers getting stuck to the air intake area.

Fig. 4. Clean motor with cover

The clean motor with cover was tested for the base operating condition and the airflow and temperature rises were measured. Test is designated as Test 2 and results are presented in Tables IV and V. Looking at Table IV, it can be seen that the average airflow at the end of the cover (and fin channels) is 16.79 [m/sec], which is equivalent to 130.4 % the average airflow without cover. In addition, Table V shows that the average temperature rise in the winding end

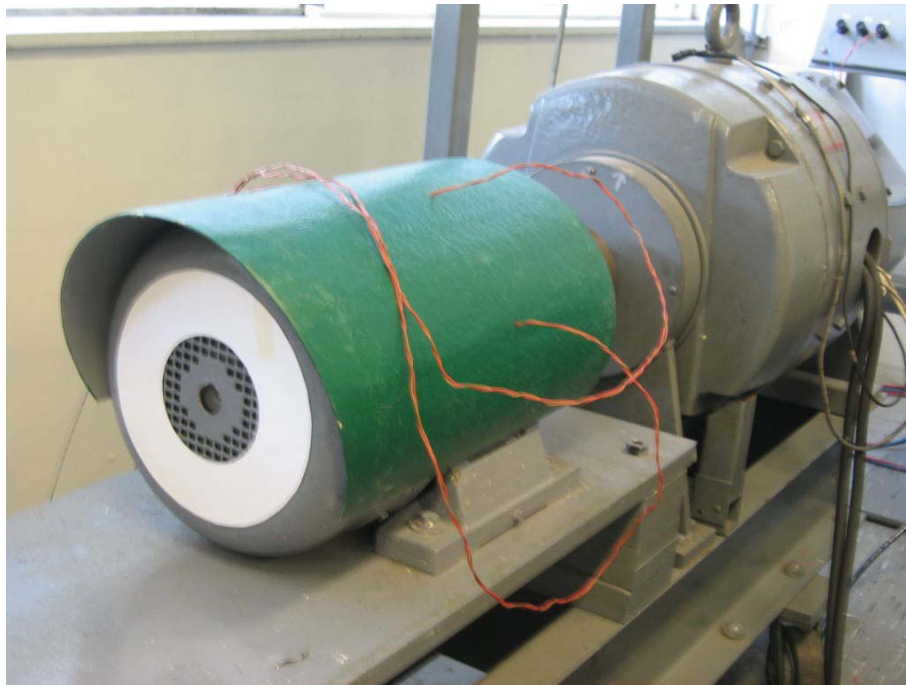
The effect of a reduction in the cooling airflow due to pulp fibers obstructing the air intake for the motor with the protecting cover is evaluated using the disk and ring covers used in [1]. Figs. 7 and 8 show the experimental motor during these tests. Tests were designated as Test 5 and Test 6, respectively, and Table VII reports the airflow measurements and Table VIII the temperature rise measurements.

Fig. 8. Clean motor with cover and ring blocking outer sector of air intake area

According to Table VII, with the disk obstructing the inner area of the air intake grid, the airflow is reduced from 16.79 [m/sec] to 12.70 [m/sec]. With the ring, which obstructs the outer area of the air intake grid, the airflow only reaches 4.99 [m/sec]. During these tests, the average temperature rises in the stator slots reach 68.7 °C (Test 5) and 78.1 °C (Test 6), which are 5.5 °C and 14.9 °C over the values for the base condition. Comparing these values to the increases measured in [1], using the disk and ring covers without the protecting cover (70 °C and 80.3 °C, respectively), it shows a marginal effect of the use of protecting covers; but most of all, the importance of keeping the air intake area clear or with only a partial obstruction that allows an airflow of at least 50 – 60 % of the rated airflow. Again in these conditions temperature rises in the DE bearing exceed the maximum allowable value, opening the possibility of a bearing failure if these values remain in time.
