EFFECT OF PROTECTING COVERS FOR TEFC INDUCTION MOTORS COVERED BY PULP

ABSTRACT

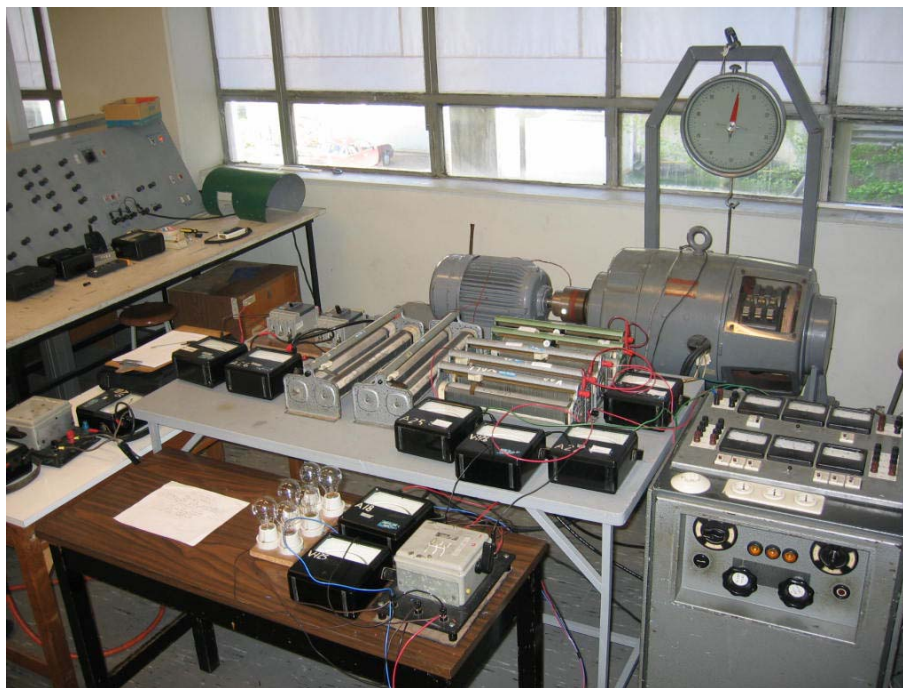
Fig. 1. General view of experimental setup

Setup is a variation of the setup used in [1]. Testing motor is a 9.2 kW, TEFC, 4 pole, class F insulation, induction motor with 14 thermocouples located in the spots of interest. Table I lists the thermocouples location, and Fig. 1 is a general view of the setup. Compared to the setup reported in [1], two thermocouples were added in the motor frame, in the interfin channels that become cut by the terminal box. Rest of thermocouples are arranged in groups of four, that cover each radial quarter of the motor (upper, bottom, right, left); groups are installed in the center of stator slots between upper and bottom coils, in the winding end turns, and in the enclosure (see Fig.2 a) and b)). Fig. 3 shows a detailed view of the thermocouples location inside the stator slots and end-turn windings, and in the enclosure.

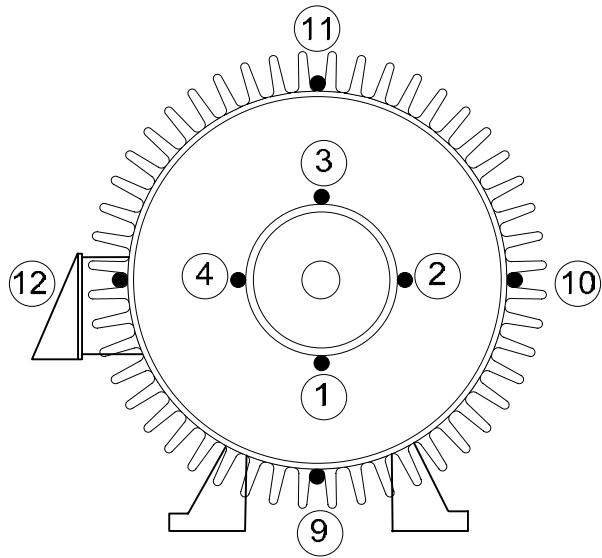
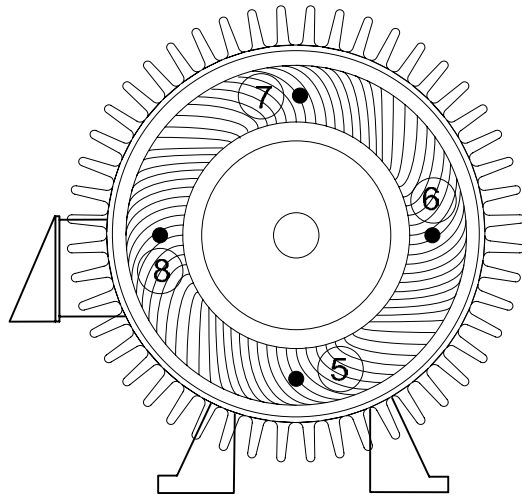
a. Thermocouples location in slots and enclosure

b. Thermocouples location in the end-turn windings

Fig. 2. Numeration and location of thermocouples in the motor

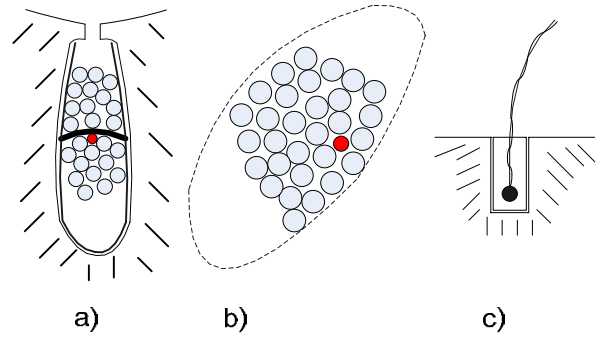
Fig.3. Detailed view of thermocouples location a). stator slots, b). end-turn winding, and c). enclosure

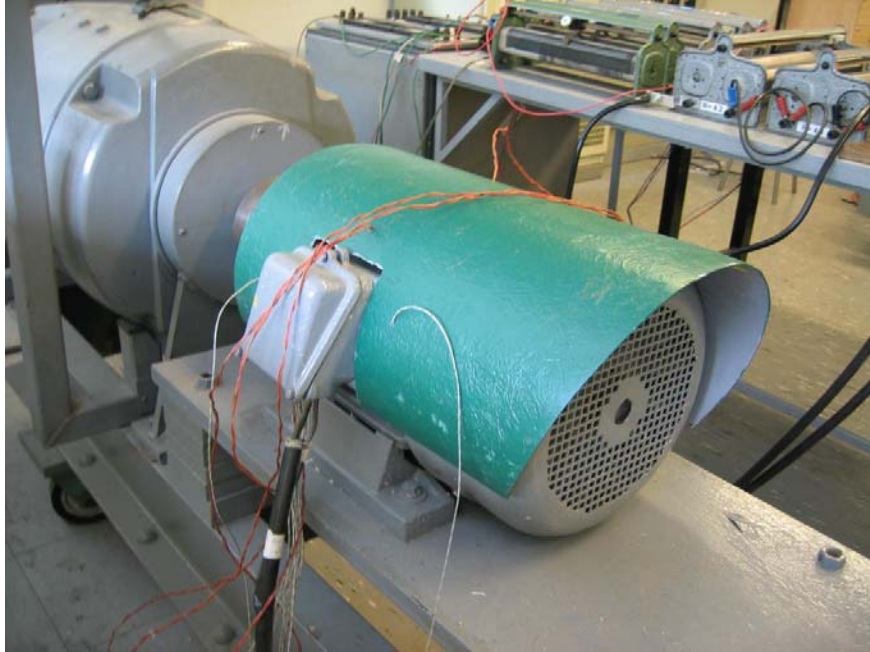
Fig. 4. Clean motor with cover

First, the effect of protecting cover is evaluated on a clean motor. Fig. 4 shows a view of the motor with the cover. It can be seen that the protecting cover surrounds the entire motor frame, with the exception of the bottom radial quarter, and therefore bringing an effective protection against the deposit of pulp in any interfin channel. Its design also includes an extension over the fan cover that avoids (or reduces) the possibility of spilled pulp or flying fibers getting stuck to the air intake area.

The clean motor with cover was tested for the base operating condition and the airflow and temperature rises were measured. Test is designated as Test 2 and results are presented in Tables IV and V. Looking at Table IV, it can be seen that the average airflow at the end of the cover (and fin channels) is 16.79 [m/sec], which is equivalent to 130.4 % the average airflow without cover. In addition, Table V shows that the average temperature rise in the winding end

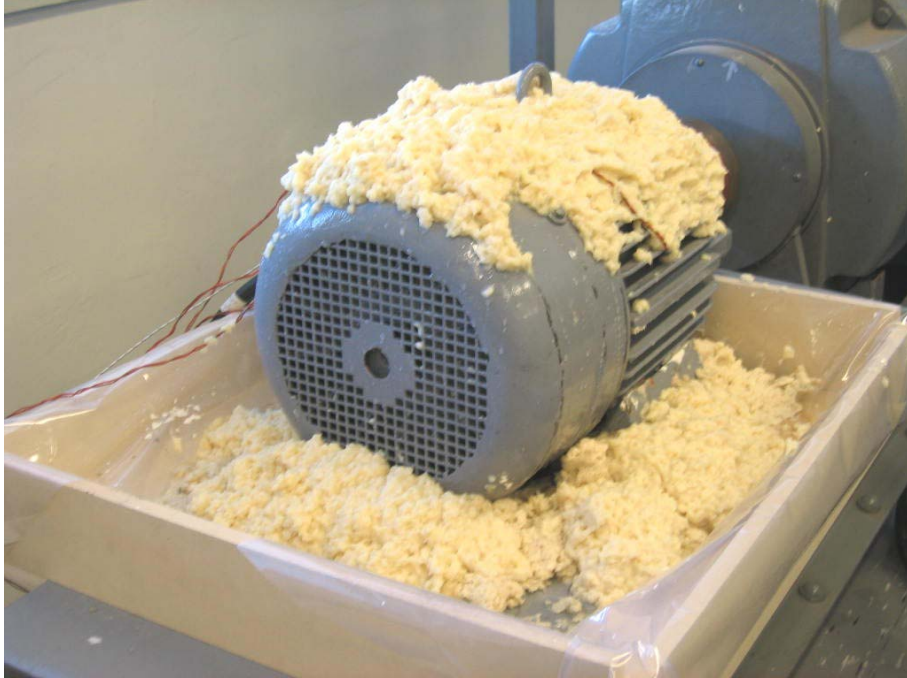
Fig. 5. Motor without cover and pulp spilled over it; clean air intake area

Next, the effect of pulp spilled over the motor, emulating an over flown tank, is evaluated. This was done pouring pulp over the entire motor. It was found that none of the pulp collects to the air inlets. This is explained because the clean motor surfaces are smooth and the wet pulp cannot stick to the almost vertical surface of air inlets. In field conditions, results should be different because the air intake area becomes dirty; the pulp fibers already collected will trap part of the wet pulp poured over the air intake, increasing the air inlet blocking. The test with pulp over the motor frame and clear air intake area is designated as Test 3. Fig. 5 shows the motor condition, and temperature rises are reported in Table VI.

According to these tables, the average temperature rise in the winding end turns in Test 3 is 74.15 °C, which is 2.85 °C higher than during base condition. For Test 4, which includes pulp splashed in the air intake, the average temperature in the winding end turns reaches 83.8 °C that is 12.5 °C over the base condition. Extrapolation of these values to rated condition, gives a temperature rise increase of 4.3 °C and 18.8 °C, respectively.

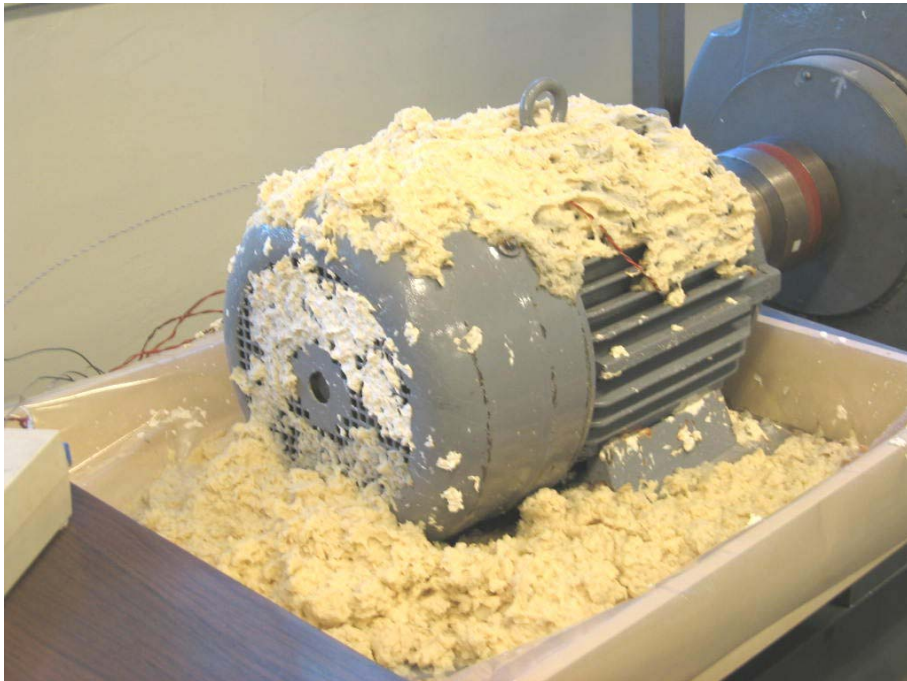
Fig. 6. Motor without cover with pulp spilled over it, and pulp splashed on the air intake area

After Test 3 was completed, pulp was splashed over the air intake area, partially covering the air inlet holes. This situation tries to emulate a more realistic field condition, as well as the effect of hosing the area and splashing pulp in the air intake net. This condition is depicted in Fig. 6. Test is designated as Test 4, and results are shown in Table VI.

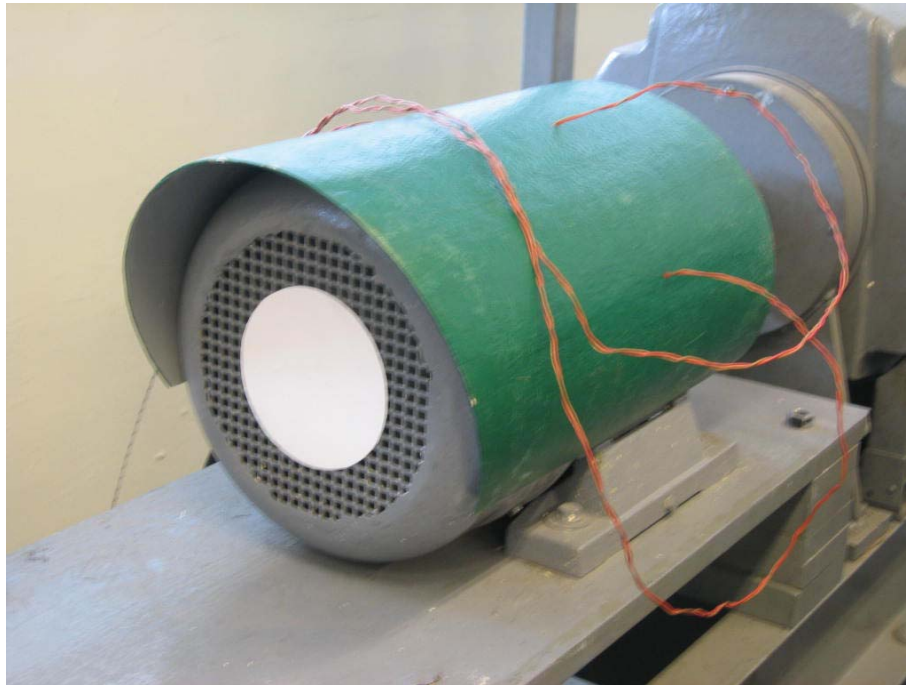
Fig. 7. Clean motor with cover and central disk blocking inner sector of air intake area

The effect of a reduction in the cooling airflow due to pulp fibers obstructing the air intake for the motor with the protecting cover is evaluated using the disk and ring covers used in [1]. Figs. 7 and 8 show the experimental motor during these tests. Tests were designated as Test 5 and Test 6, respectively, and Table VII reports the airflow measurements and Table VIII the temperature rise measurements.

According to Table VII, with the disk obstructing the inner area of the air intake grid, the airflow is reduced from 16.79 [m/sec] to 12.70 [m/sec]. With the ring, which obstructs the outer area of the air intake grid, the airflow only reaches 4.99 [m/sec]. During these tests, the average temperature rises in the stator slots reach 68.7 °C (Test 5) and 78.1 °C (Test 6), which are 5.5 °C and 14.9 °C over the values for the base condition. Comparing these values to the increases measured in [1], using the disk and ring covers without the protecting cover (70 °C and 80.3 °C, respectively), it shows a marginal effect of the use of protecting covers; but most of all, the importance of keeping the air intake area clear or with only a partial obstruction that allows an airflow of at least 50 – 60 % of the rated airflow. Again in these conditions temperature rises in the DE bearing exceed the maximum allowable value, opening the possibility of a bearing failure if these values remain in time.

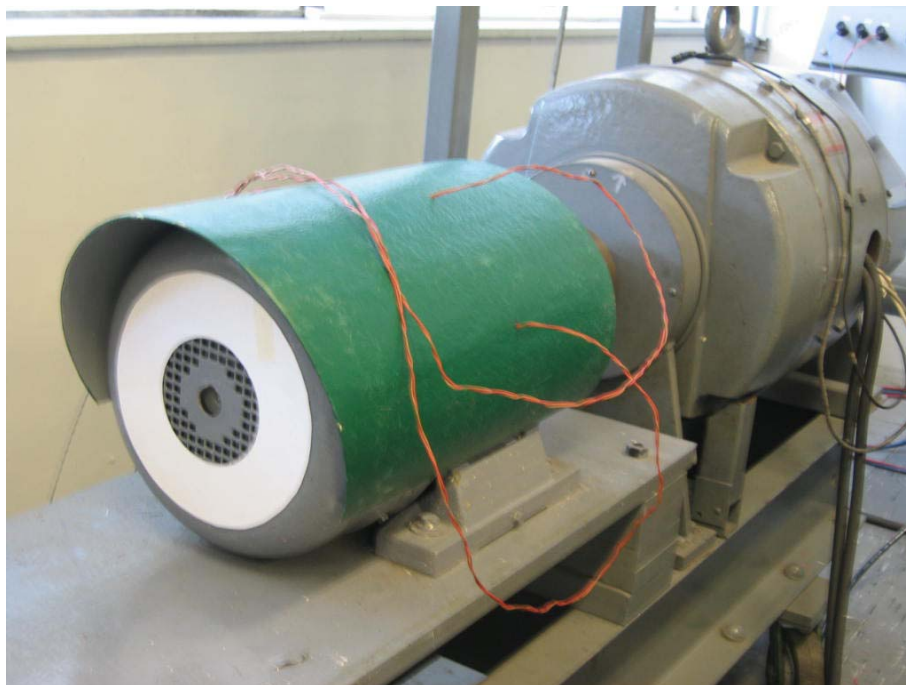
Fig. 8. Clean motor with cover and ring blocking outer sector of air intake area

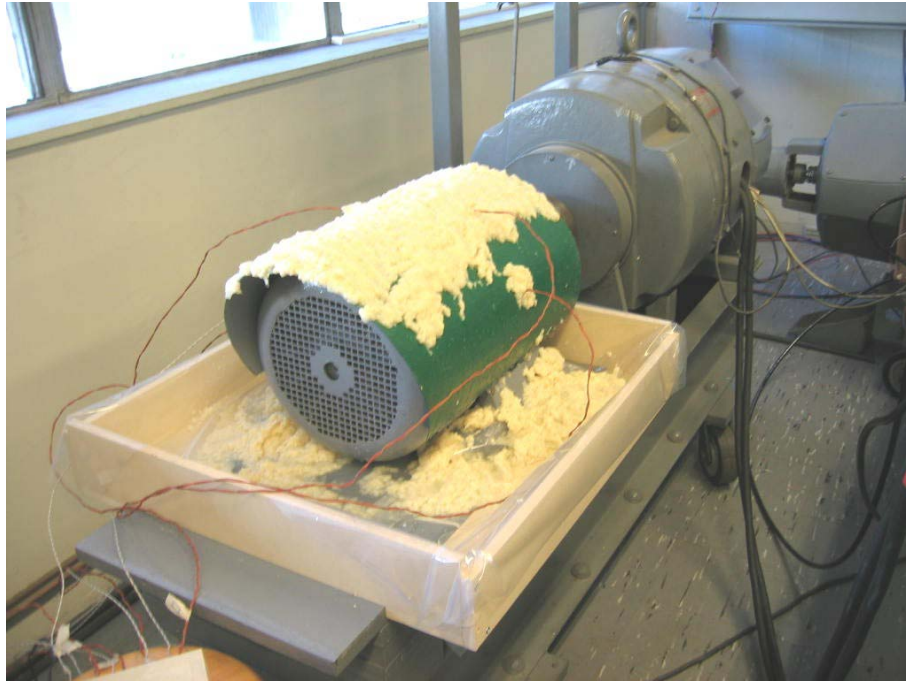
Fig. 9. Motor with pulp spilled over the cover; clean air intake area

Test 7 corresponds to the motor with cover and wet pulp poured over the cover. In this test the air intake area remains clear. Fig. 9 shows a view of the motor during this test and Tables IX and X report the airflow and temperature rises.

During Test 7, as the air intake area remains clear, the airflow keeps the same value of Test 2, for the clean motor with cover. Similarly, the presence of pulp over the cover does not affect the heat transfer from the fins to the cooling air, and temperature rises during Test 7 are almost identical to the values measured in Test 2. Differences are less than 1 °C, explained by small differences in the control of load condition and/or data reading errors.

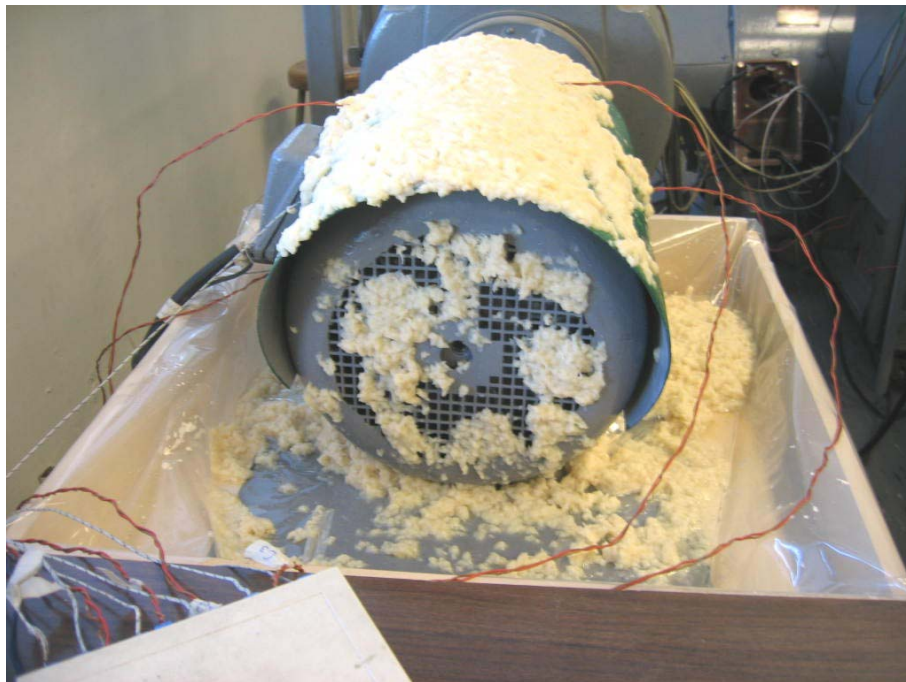
Fig. 10. Motor with pulp spilled over the cover and pulp splashed on the air intake area

Then, wet pulp was splashed over the air intake grid, obstructing the airflow (see Fig. 10), and the motor was tested using the same base condition. This test is designated as Test 8, and the results are summarized in Tables IX and X.

In Test 8, the obstruction of the air inlets affects the airflow, and as a direct effect of this reduction, produces an increase in the temperature rises. According to Table IX the airflow is

reduced to 8.90 [m/sec]. Table X shows that the temperature rise in the stator slots reaches 71.85 °C, which is 10 °C degrees higher than the temperature rise during base line test (Test 1). These results are consistent with the values obtained during Tests 5 and 6, where the airflow was reduced to 98.61 % and 38.75 %, respectively, confirming the importance of keeping the air intake grid clear.
